# Portage Creek Sediment Remediation Project Kalamazoo, Michigan

Pre-Sediment Removal Structure Feature Assessment  
Removal Areas SA3-A, SA3-B and SA3-Access

F&V Project Number: 809930

August, 2012

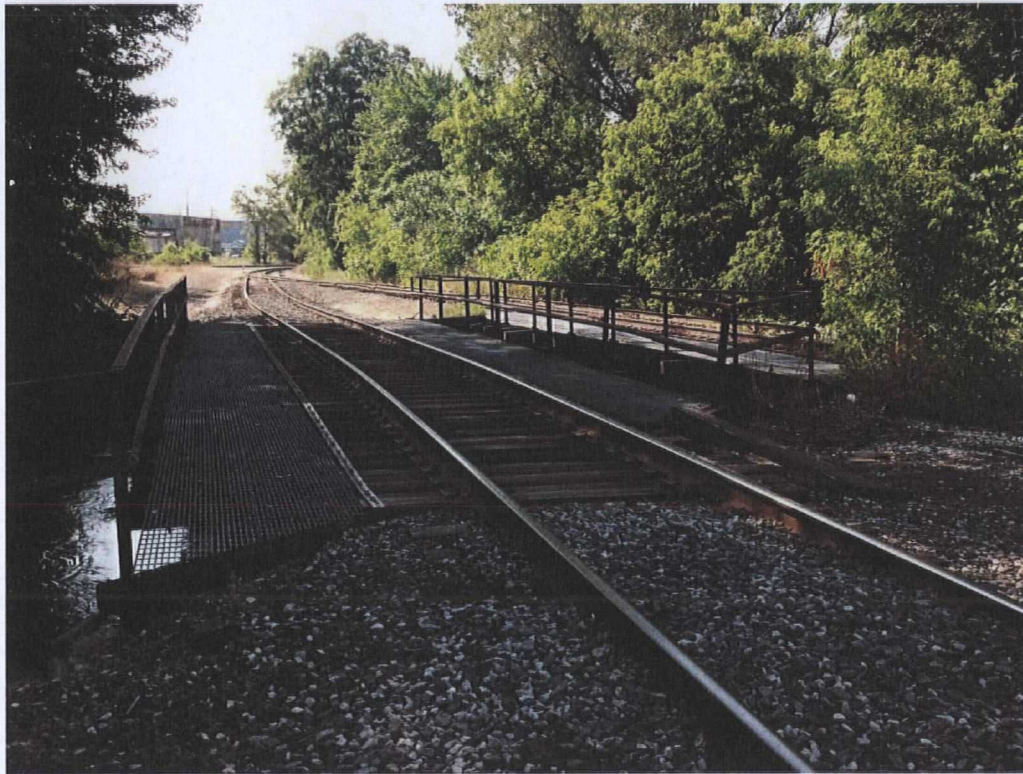
Structure viewed from track level

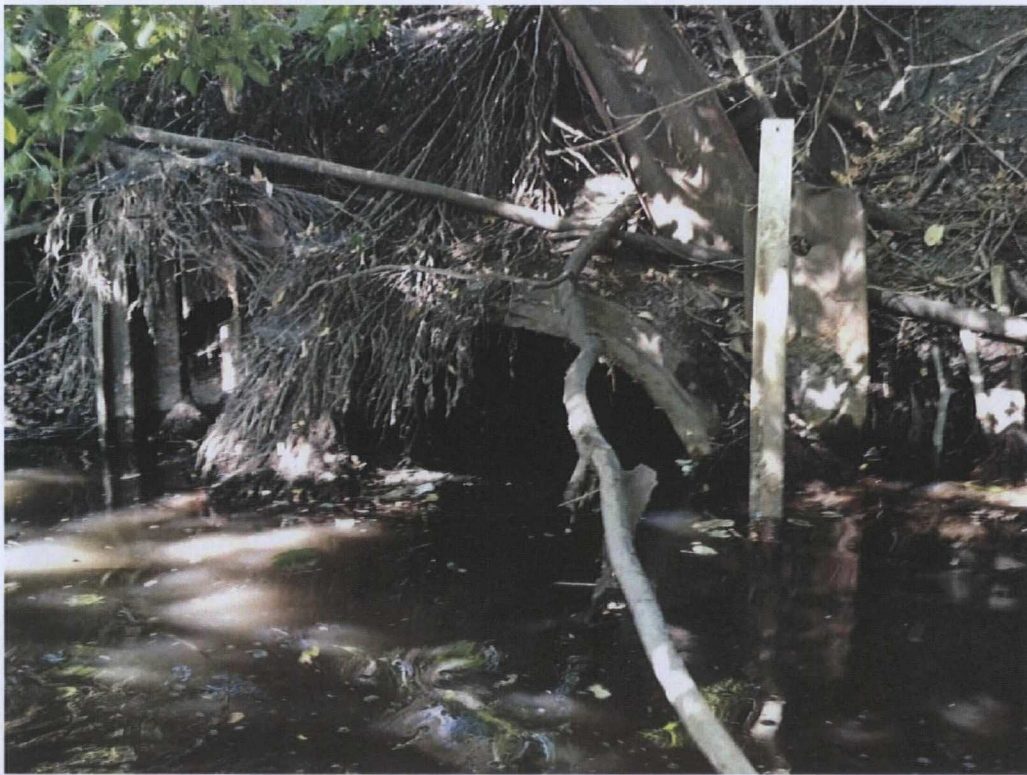
Concrete outlet in the southwest with failed sheet pile headwall

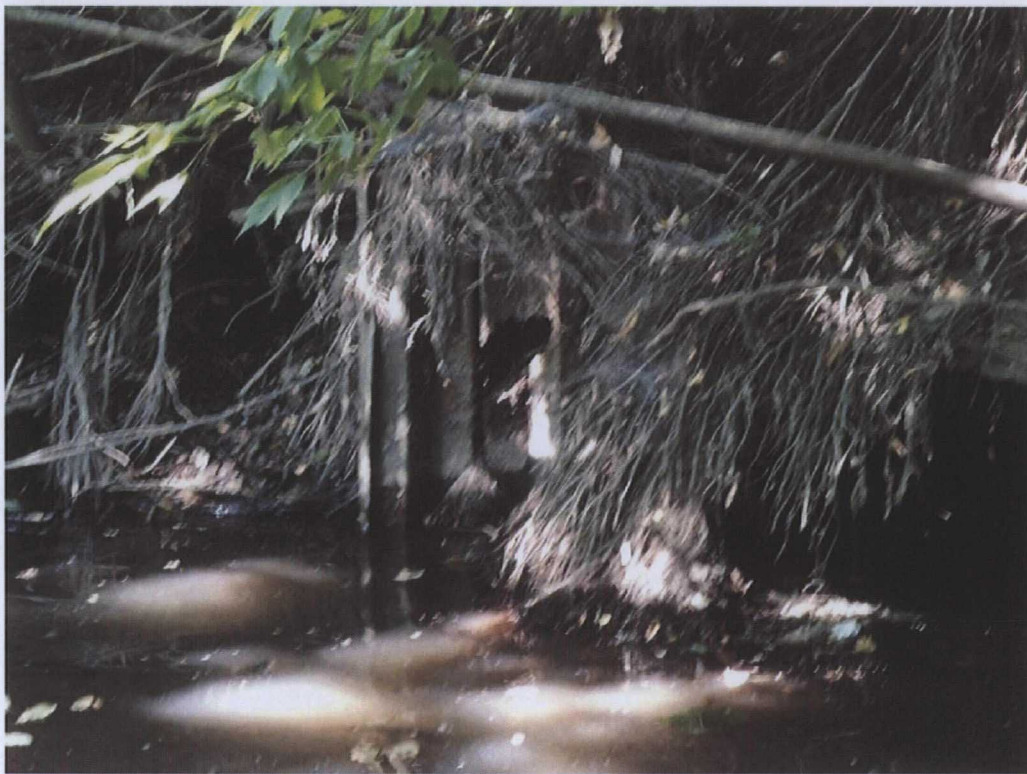
Failed sheet pile in the southwest

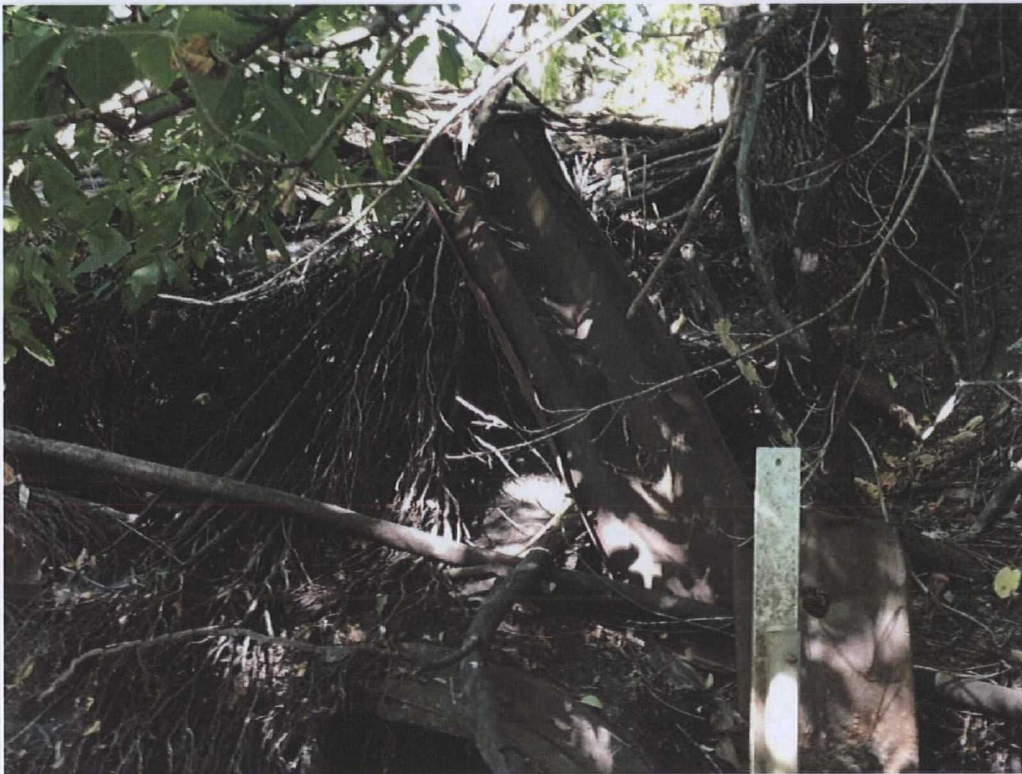
Failed sheet pile in the southwest

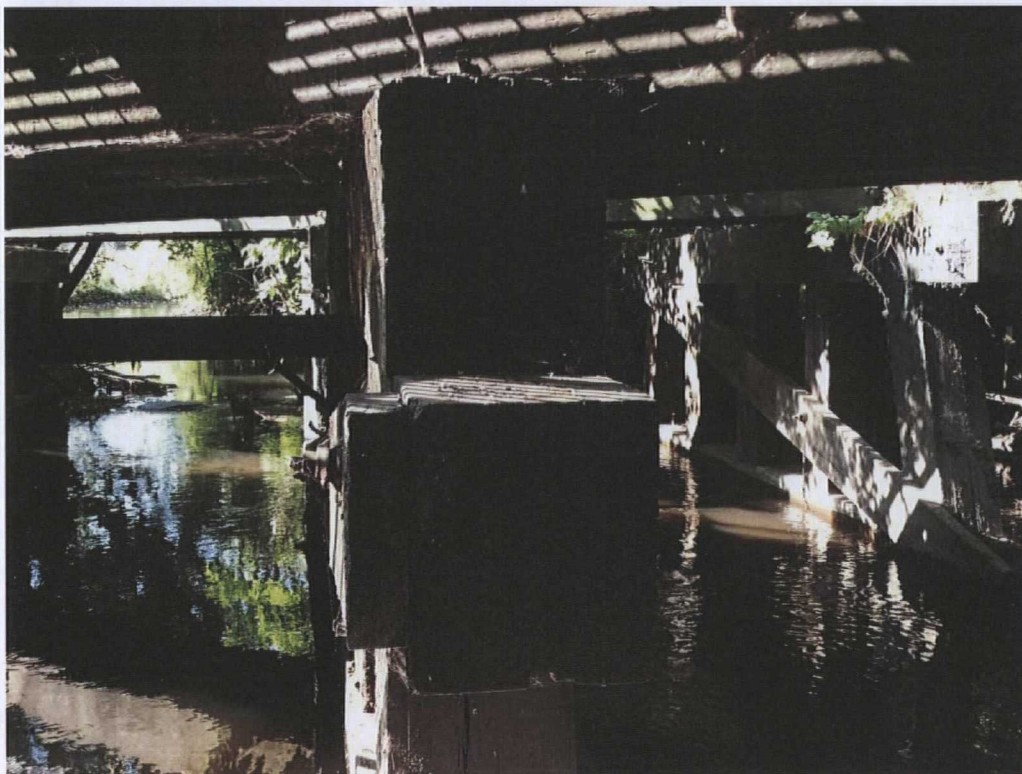
Checking and splitting on ends of timber beams

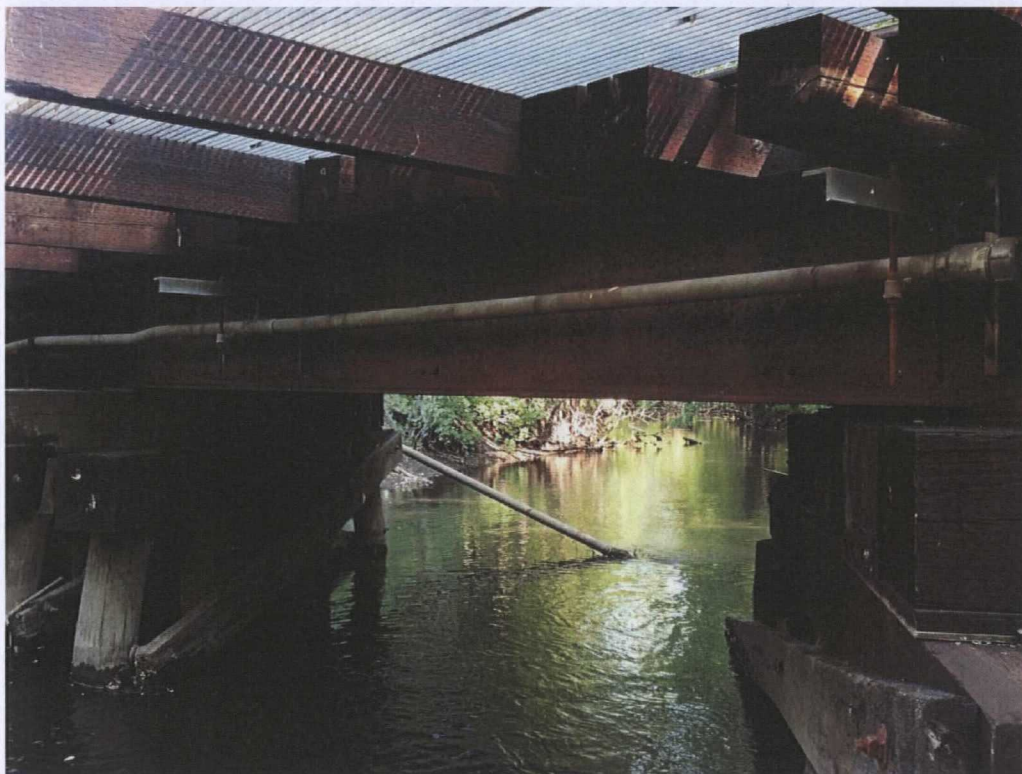
Corrosion and section loss on steel girder

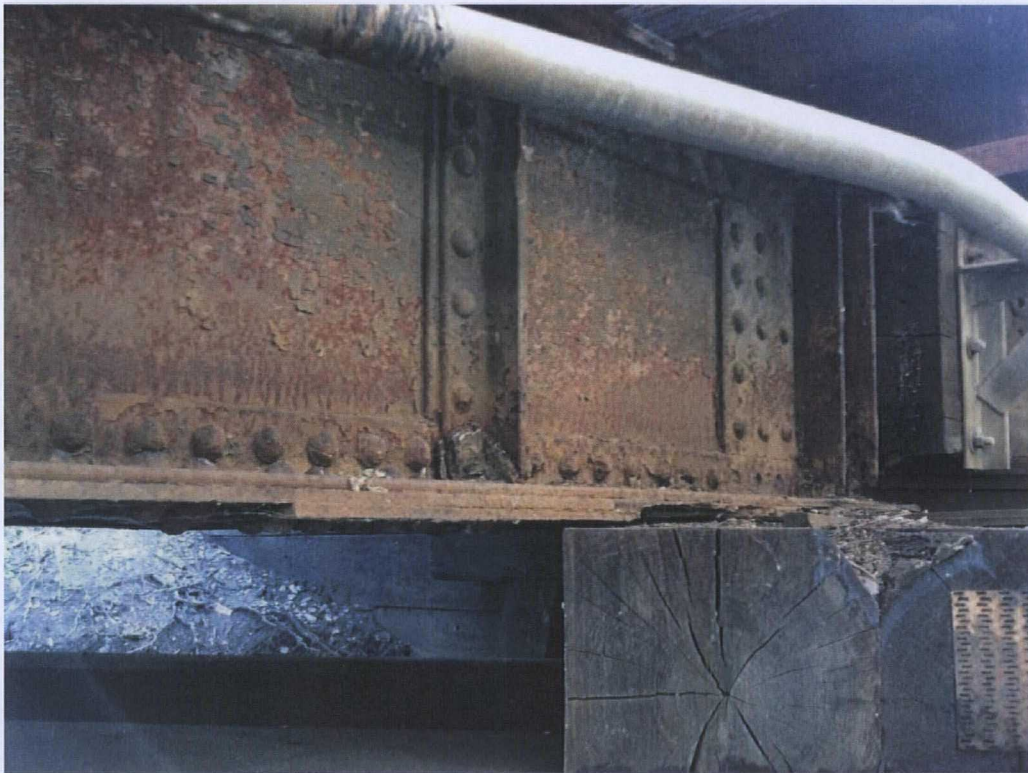
Corrosion and section loss on steel girder and checking on timber beam

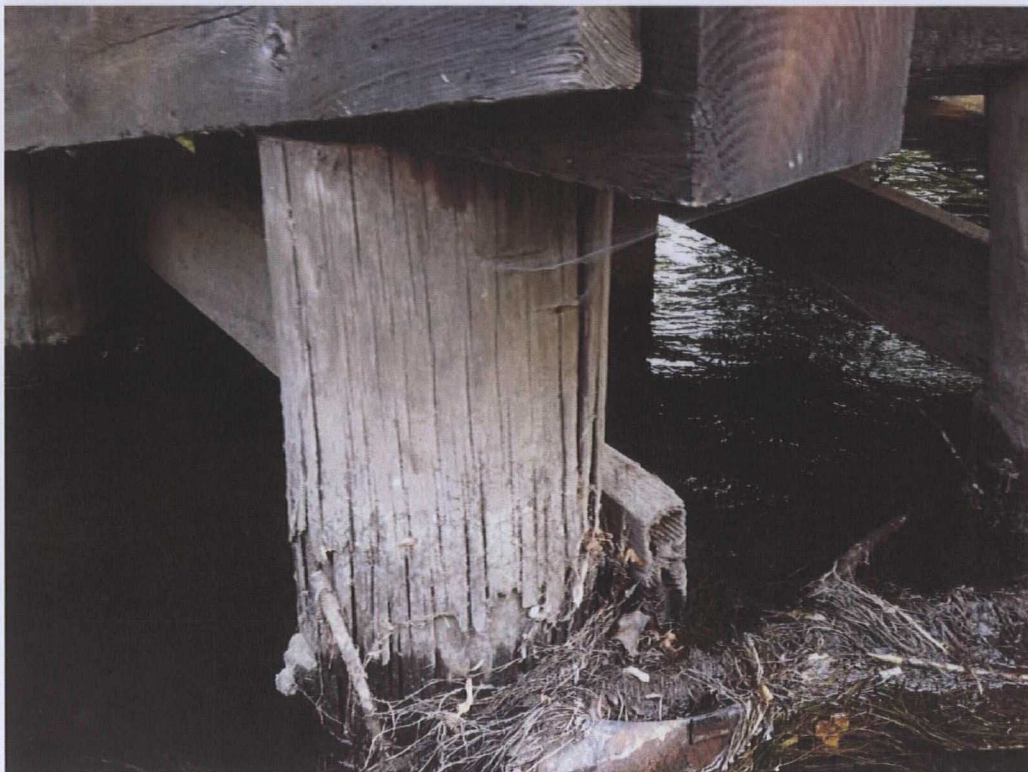
Brooming of timber pile

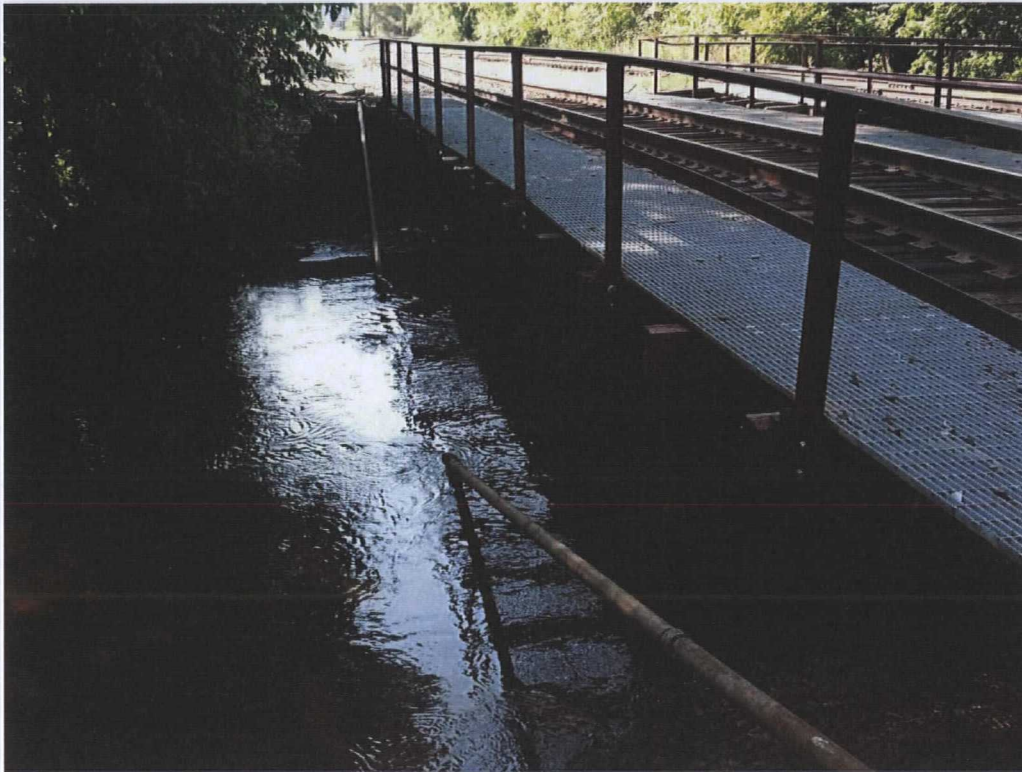
Failed conduit on north side of north structure

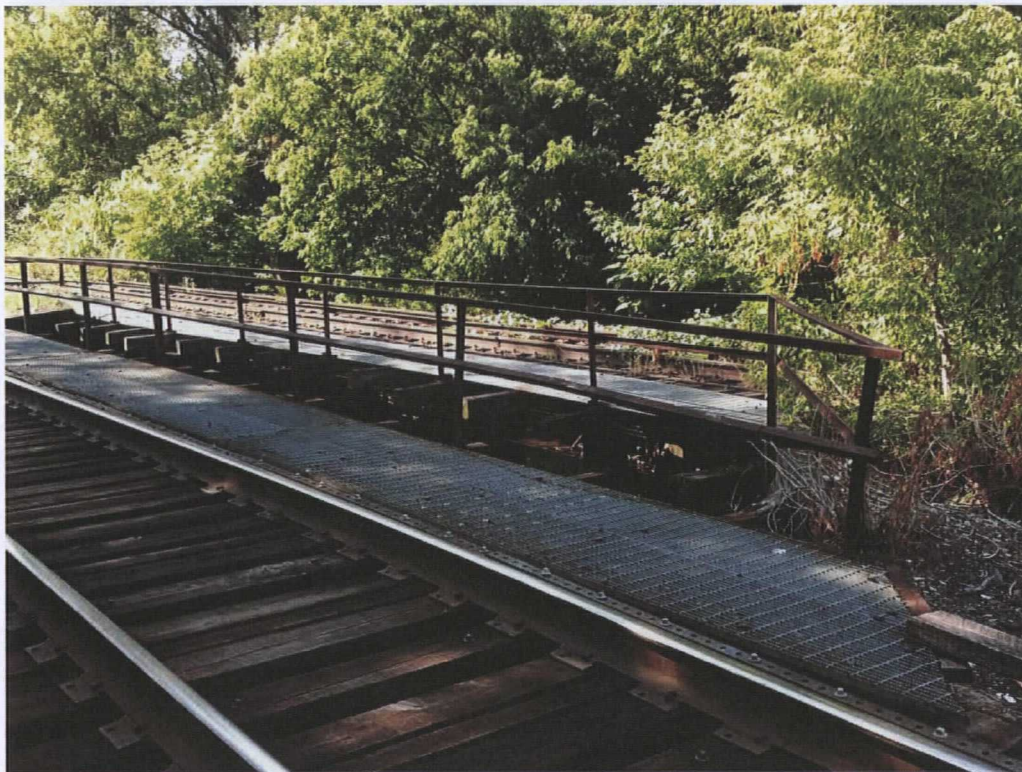
Brush growth encroaching on structure

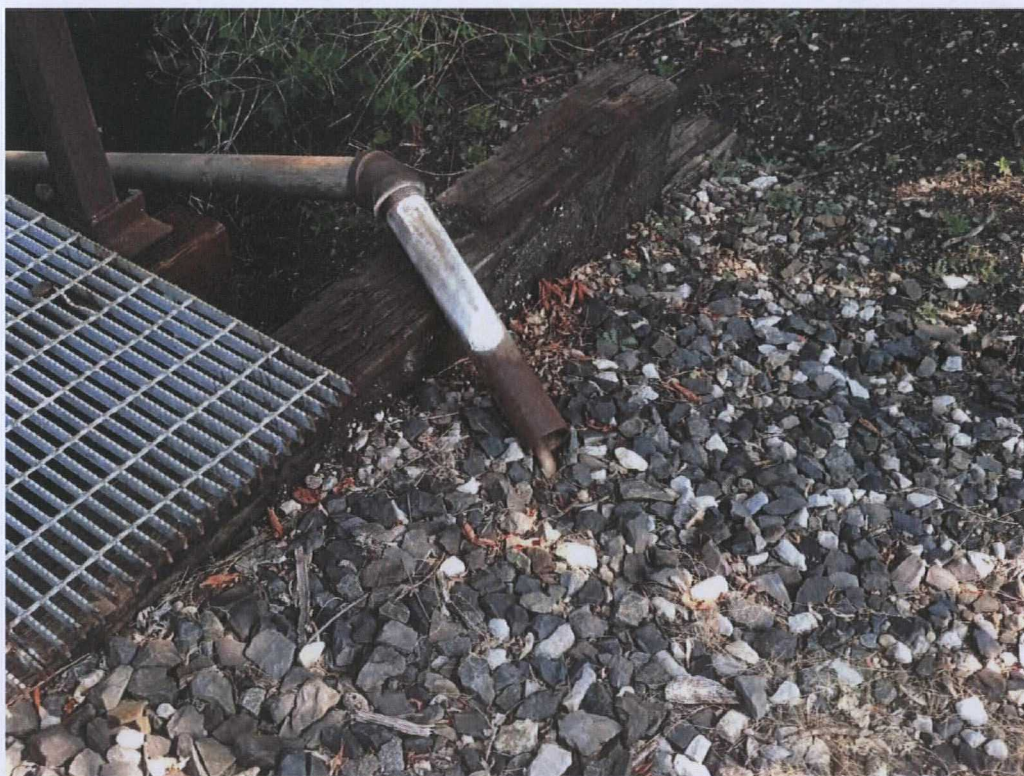
Cable inside conduit exposed at grade from conduit failure

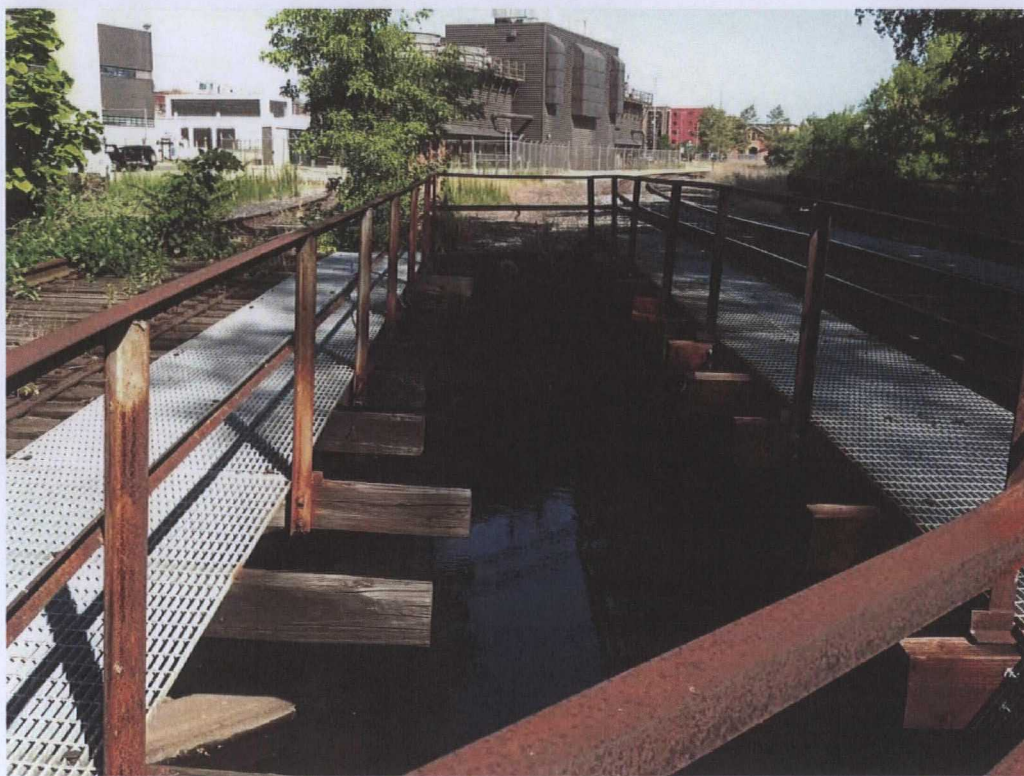
Corrosion on steel railings

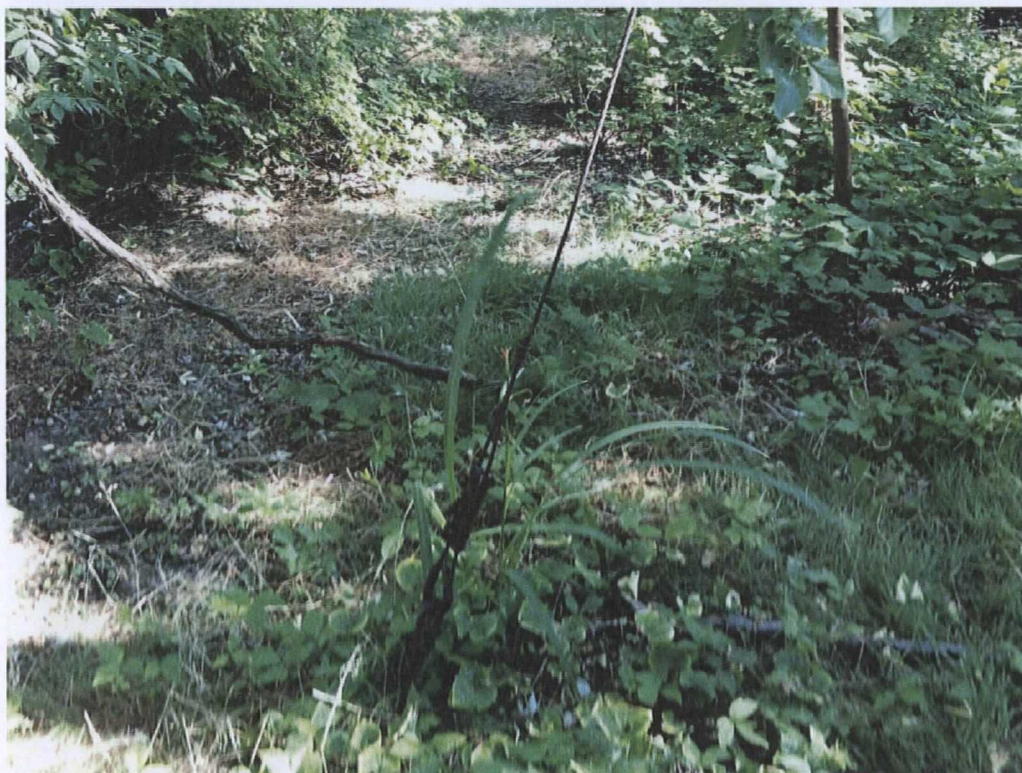
- The timber pole has minor splitting. It leans toward the channel slightly.
- The steel guy wire and support have moderate corrosion.

Corrosion on the guy wire and anchorage

- We understand that sediment removal in SA3-A will extend into this floodplain area along the east bank. Sediment should not be removed within the 1:1 influence area of the pole or guy anchor unless the pole is supported during the work.
- Construction fencing or similar means should be used to identify the pole and guy to operators and drivers during the work.

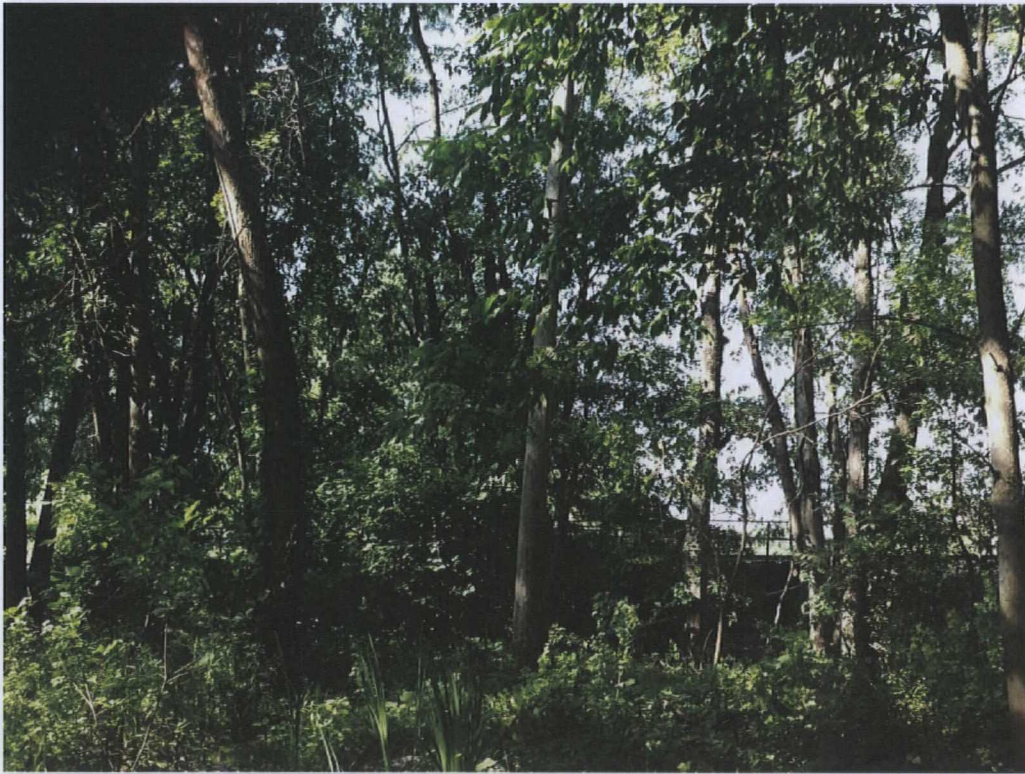
View of the pole from the north showing slight lean toward the channel

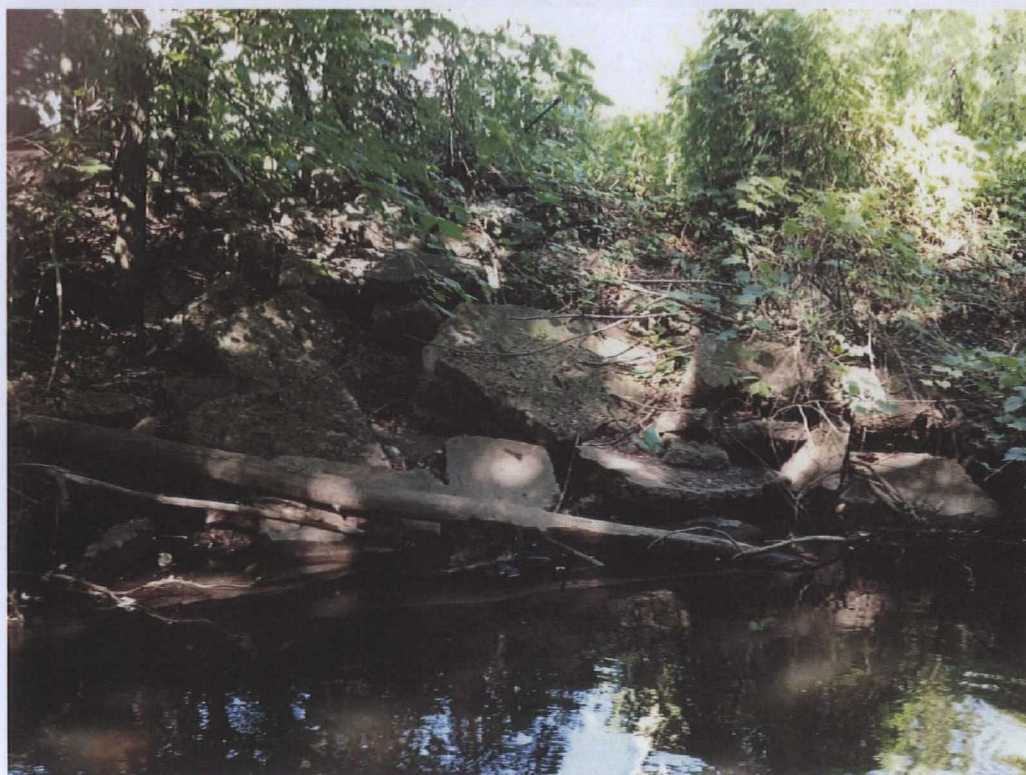
- The concrete slabs have moderate undermining along the waterline.
- A number of slabs have settled into the channel.

Undermined slabs along the waterline

- The slabs should be removed and replaced as required to facilitate sediment removal.

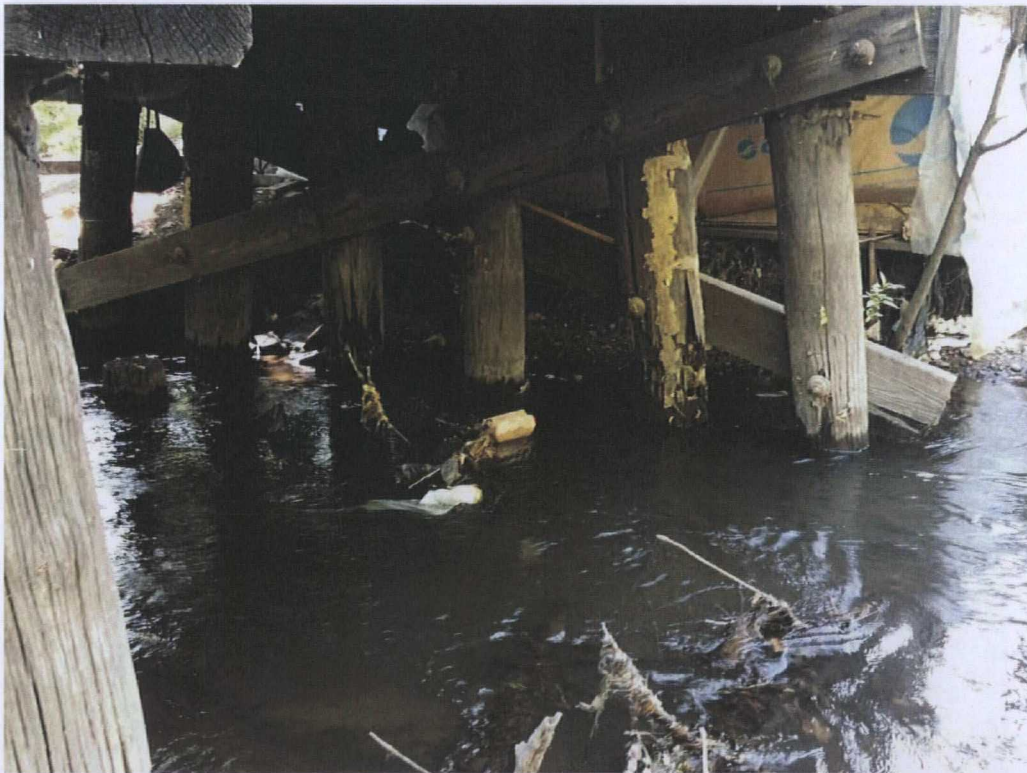
Severe section loss on timber piles of east pier

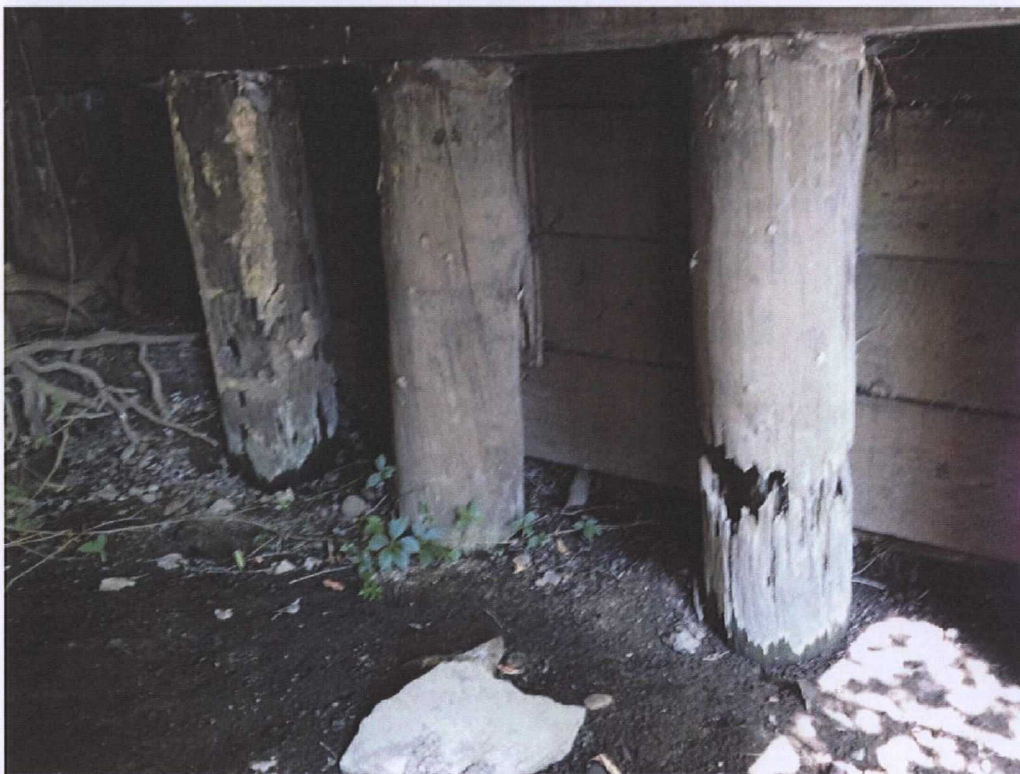
Failed timber pile at abutment

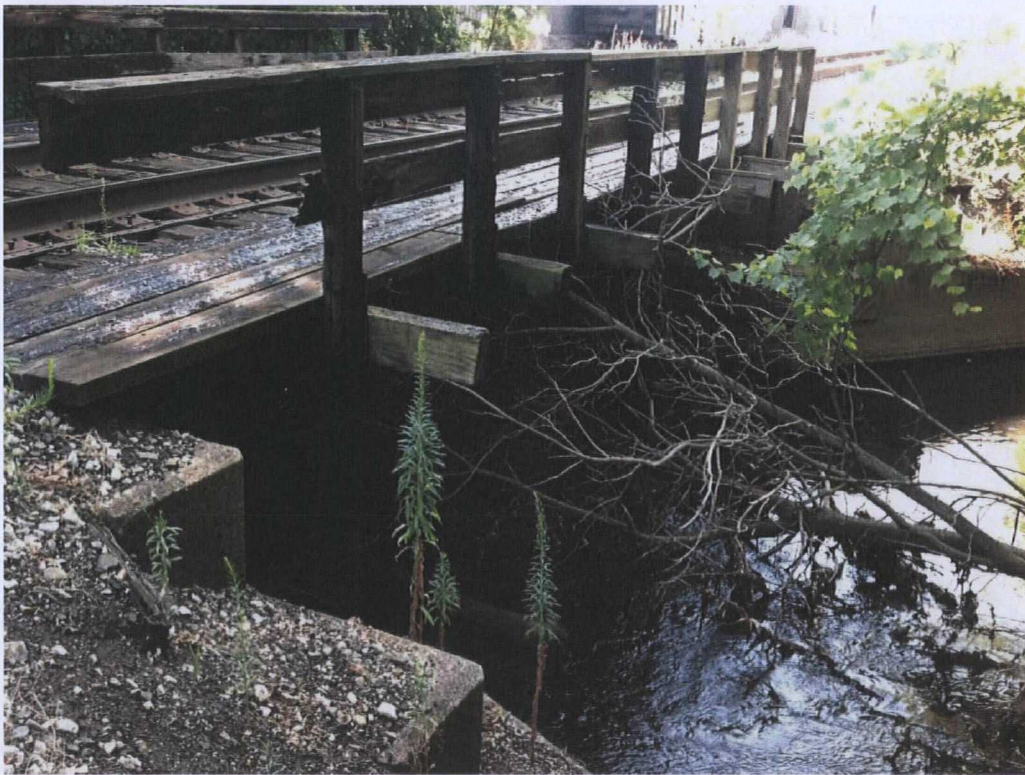
Large tree in channel at structure

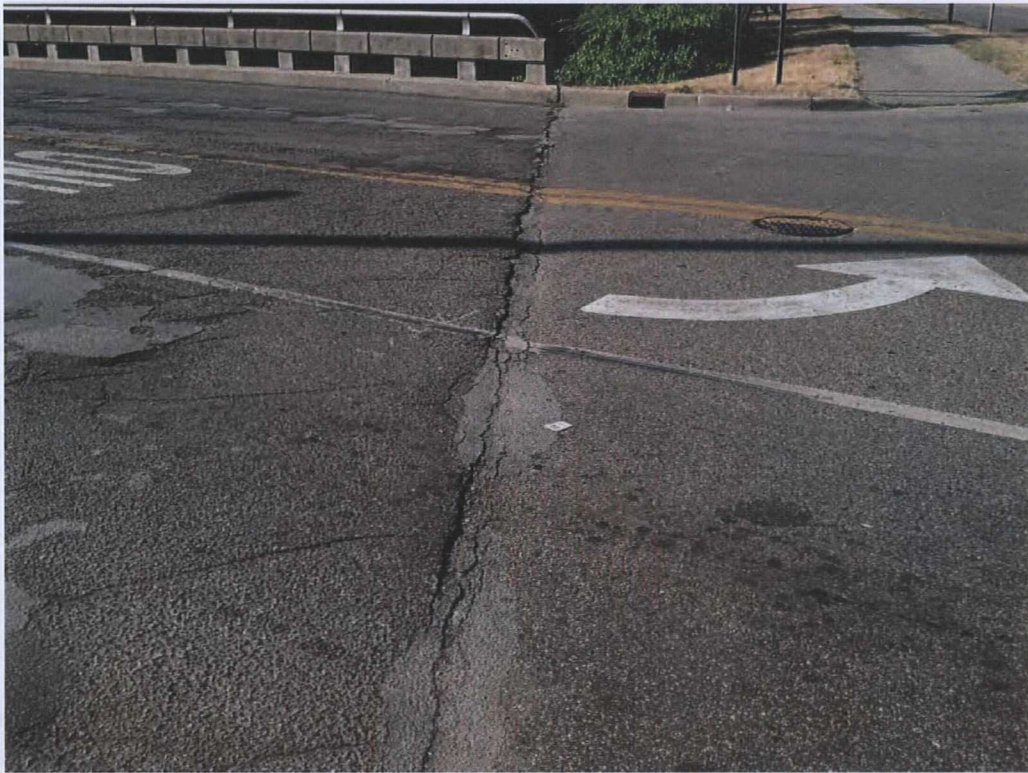
Cracking and cold patch along west reference line

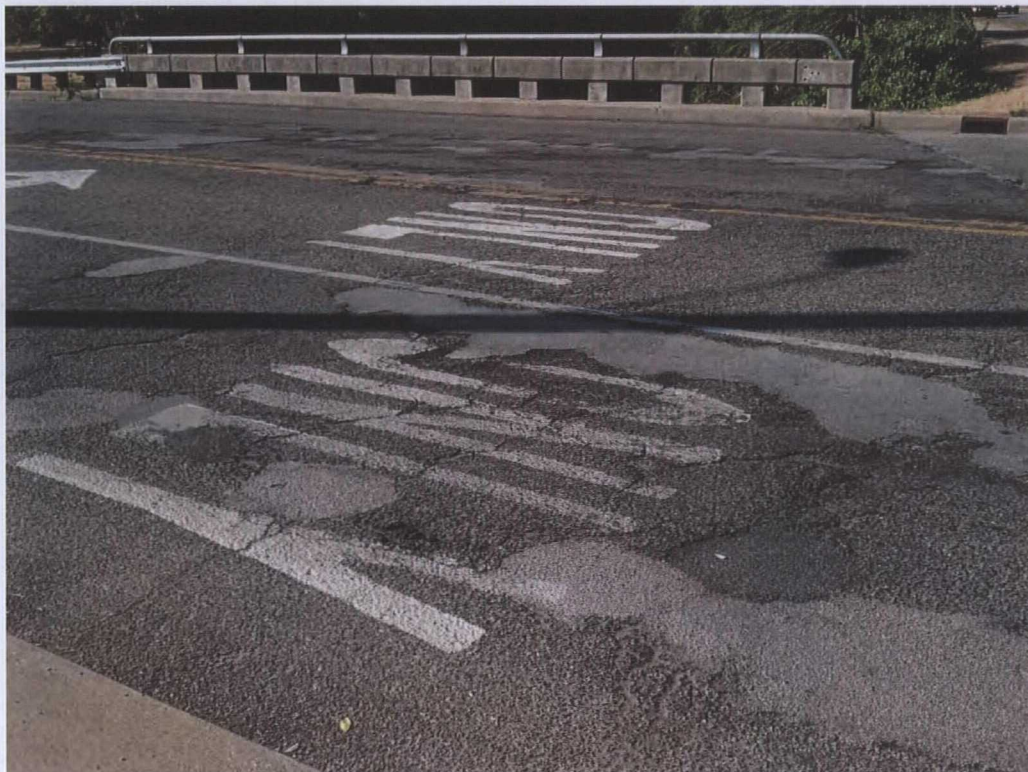
Spalling and cold patch in asphalt wearing surface

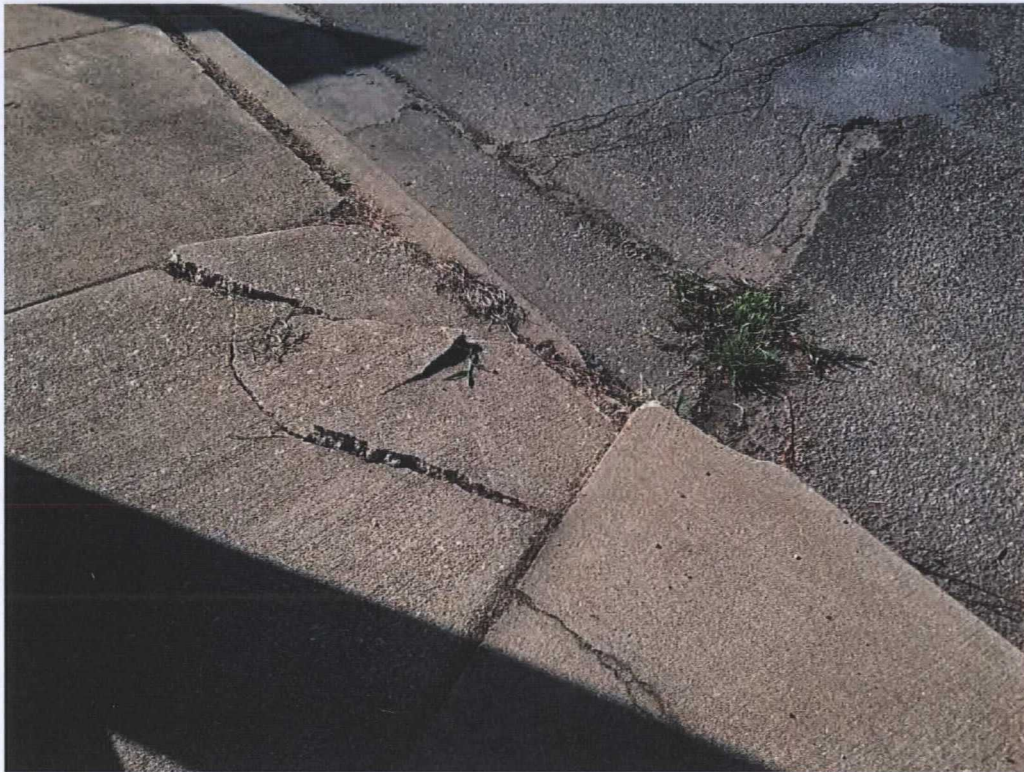
Cracking and spalling of approach sidewalk

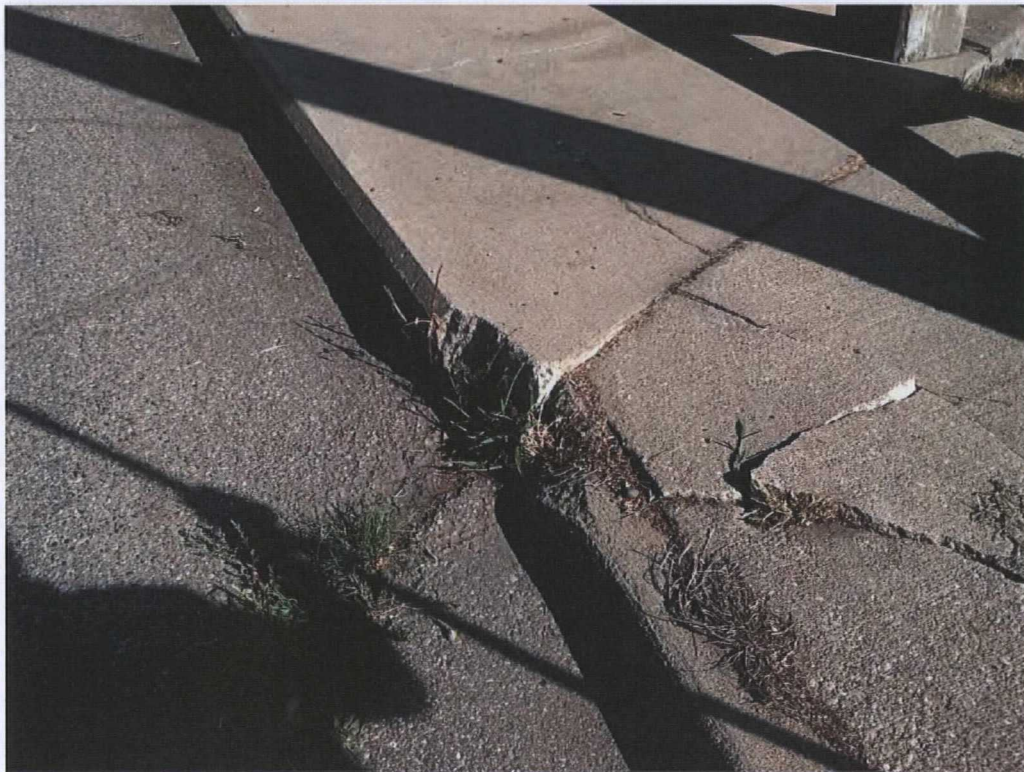
Corner spalling on curb and sidewalk in northeast

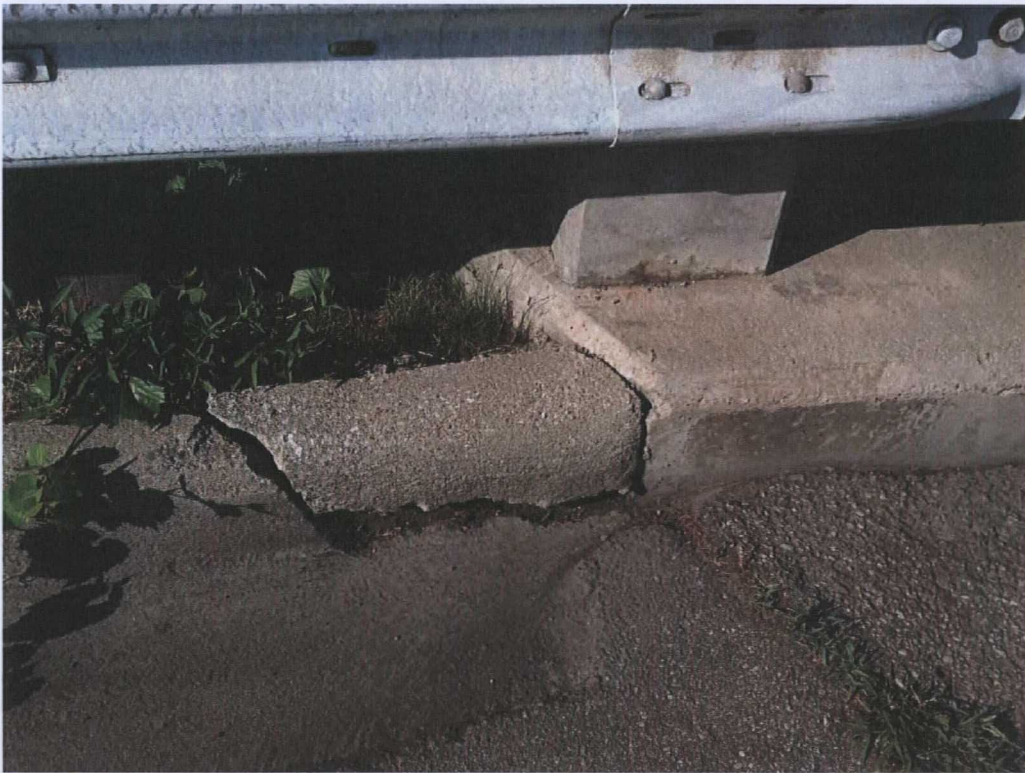
- The southeast concrete curb has severe cracking.
- The southeast guardrail has moderate collision damage and is bowed outward.
- There is a water main suspended along the south fascia.

Critical cracking of southeast approach curb

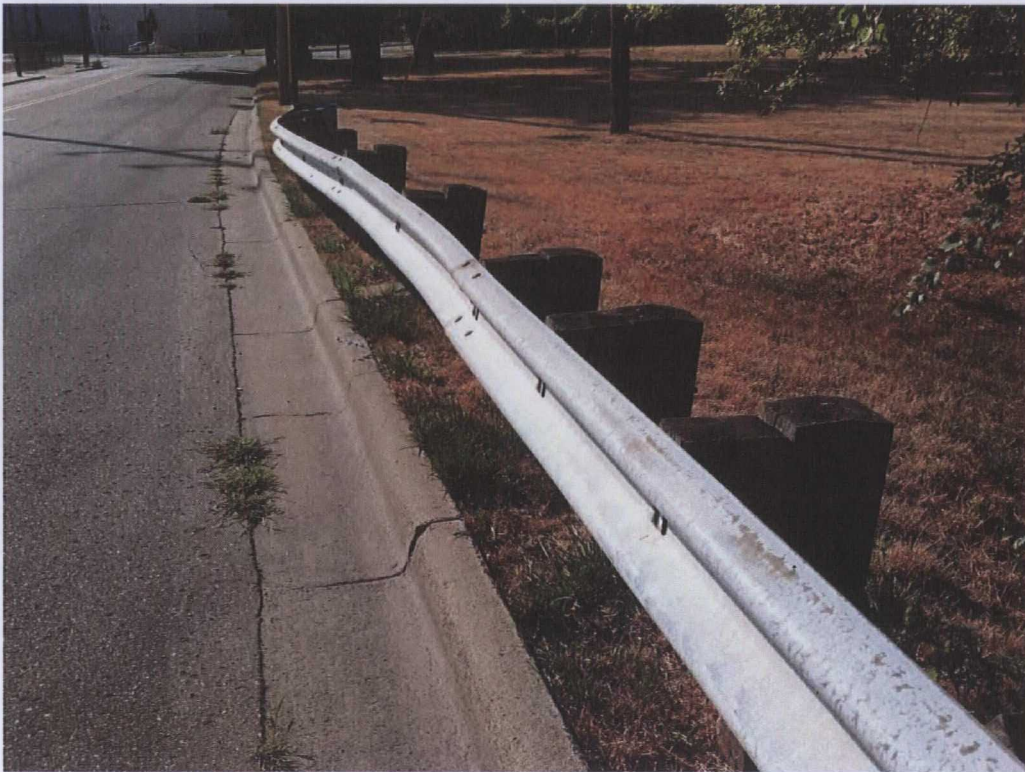
Bowed guardrail in southeast

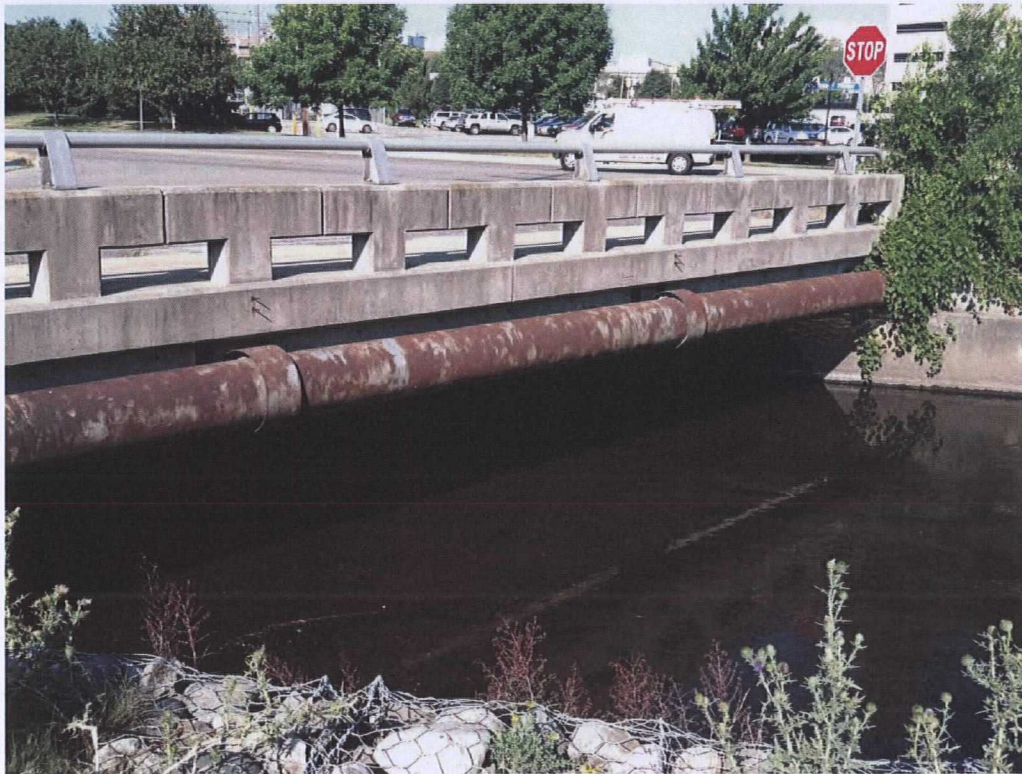
Corrosion on utility supported along north fascia

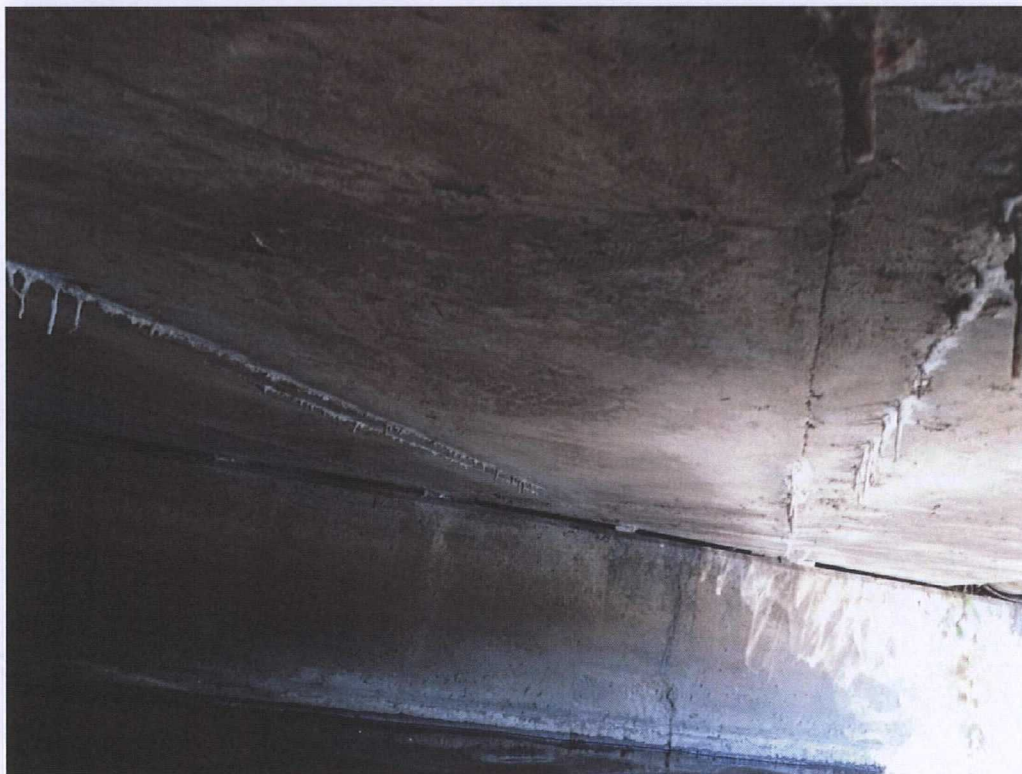
Efflorescence and stalactites along box beam joints

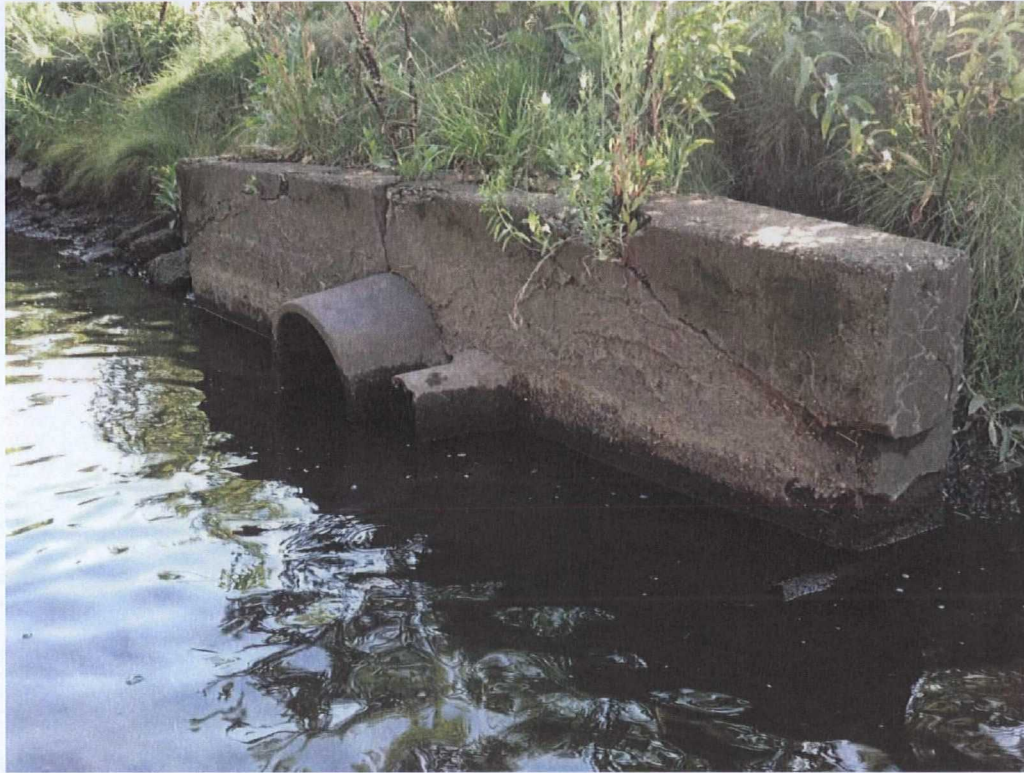
- The bank is severely eroded around the structure, exposing the clay pipes behind the headwall.
- The concrete headwall has moderate to severe cracking.

View of structure from south channel showing cracking and spalling of headwall

- If a cofferdam is required for dewatering, it should be installed with a minimum 4' clearance to the headwall to avoid adversely impacting it. We recommend contacting the property owner for permission to remove the headwall and cut off the outlets at the bank.

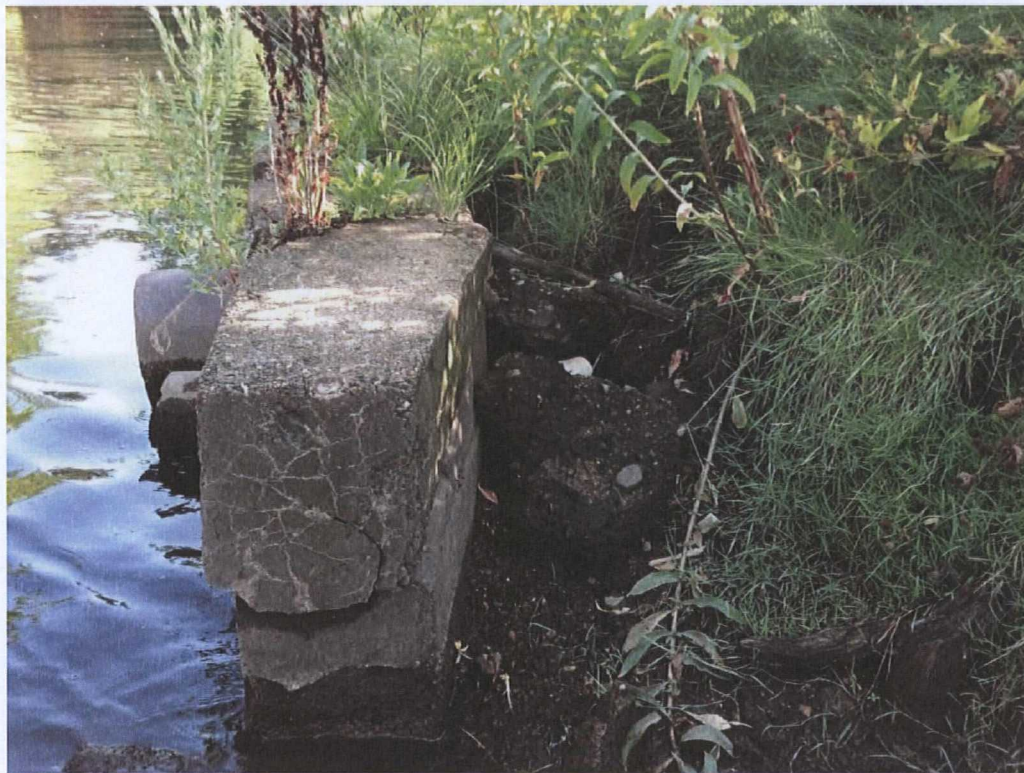
Severe bank erosion behind headwall
